# Public Information Meeting

## Update on Conditions and Environmental Actions at the Former Kerr-McGee Wood Treatment Facility Springfield, MO

**September 14, 2016**

Greenfield Environmental Multistate Trust LLC  
Trustee of the Multistate Environmental Response Trust

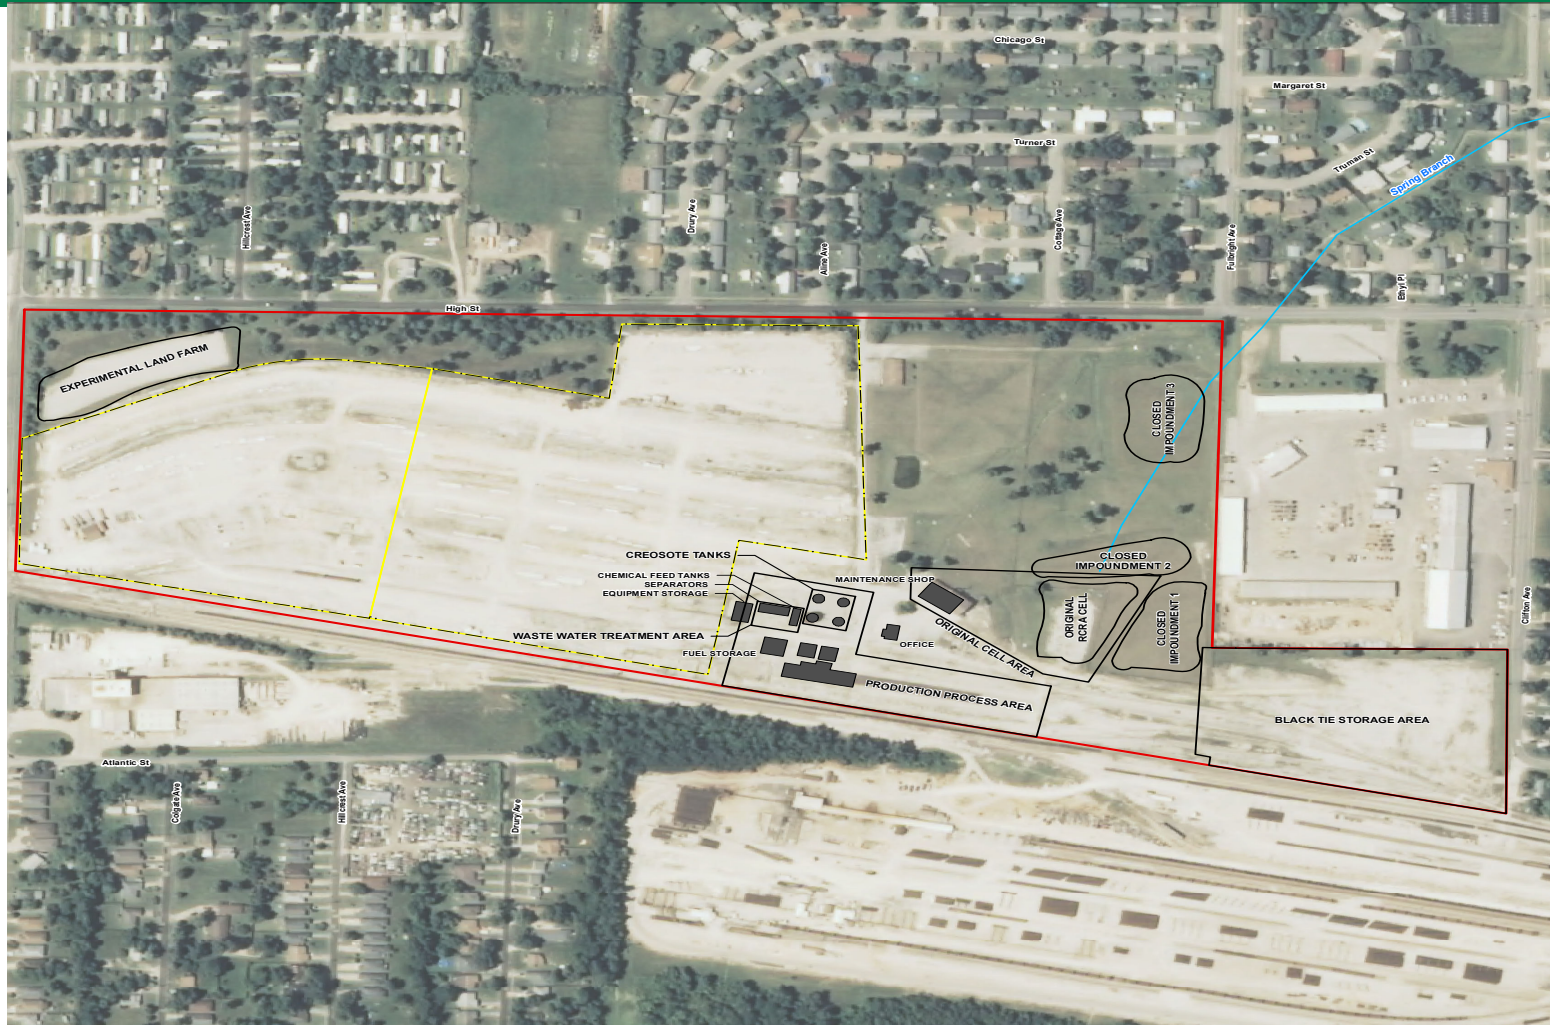
- Kerr-McGee was forced to close:
  - Several solid waste management units
  - 3 surface impoundments
  - Land farm treatment unit
- Closure involved contaminated soil removal and placement of caps on surface impoundments

# Kerr-McGee Remedy Actions Under MoDNR Oversight

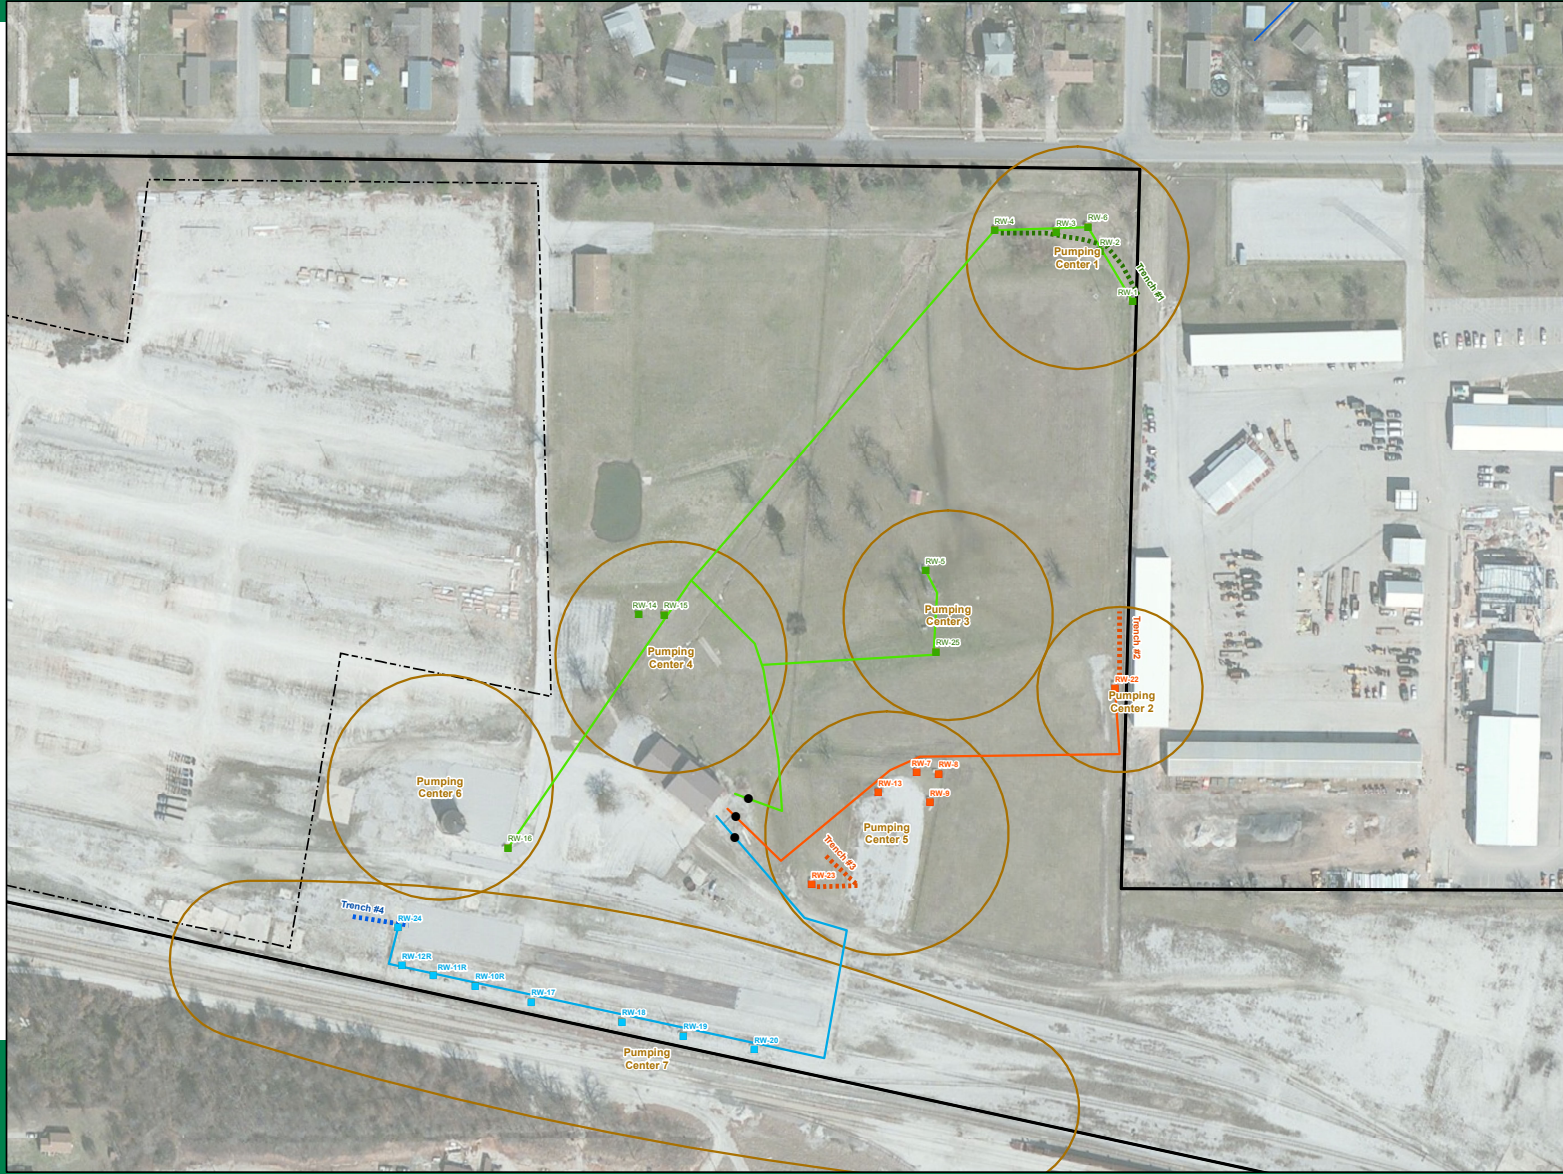
Uppermost Flow Zone  
Recovery Well and Pumping Center  
Location Map

- Trenches and pumps
  - Recover creosote
  - Remove contaminated groundwater
  - Limit movement of groundwater
- On-site treatment system
  - Collect creosote
  - Treat groundwater
- Groundwater wells to monitor conditions and remediation effectiveness

# Recovery Trenches and Pumps Located in Contaminated Areas

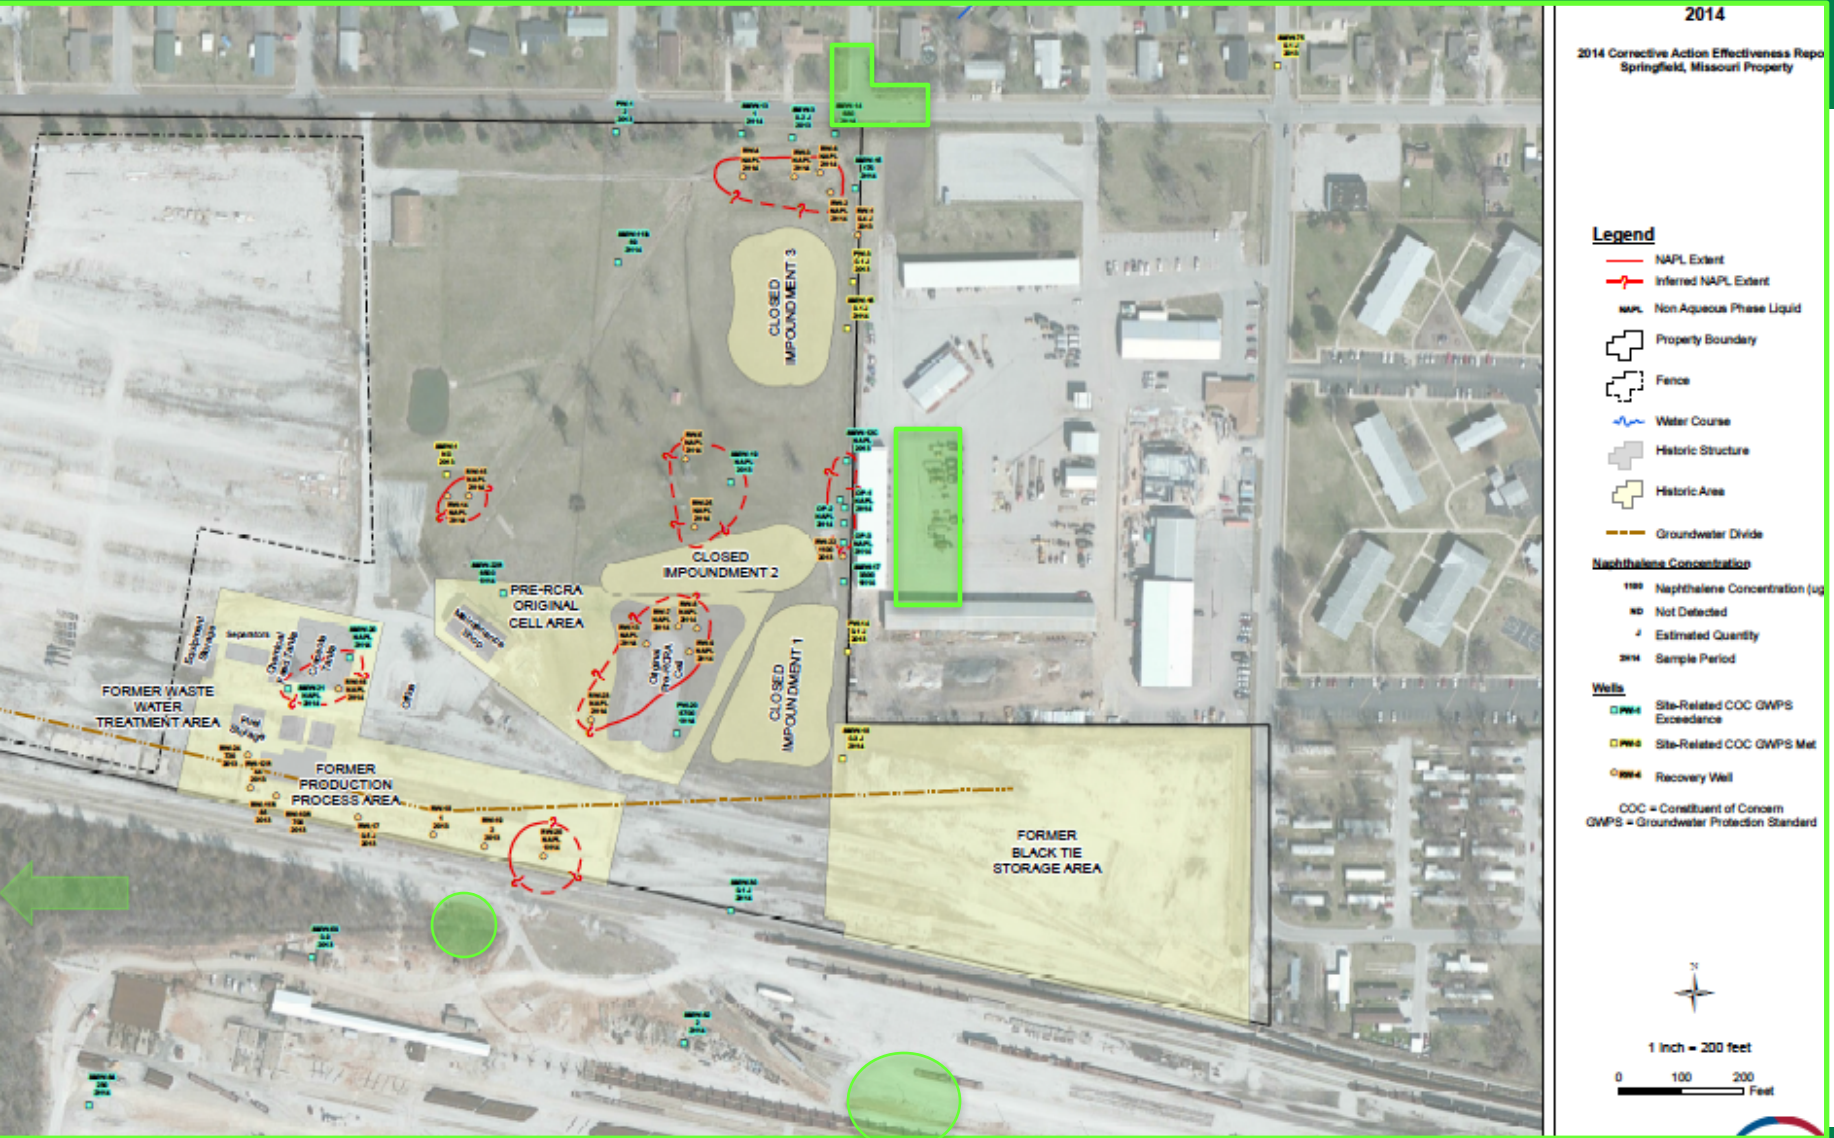
# Areas Being Investigated in Fall 2016
