Former Tronox/Kerr-McGee Facility

Community Update

Springfield, Missouri

August 23, 2023

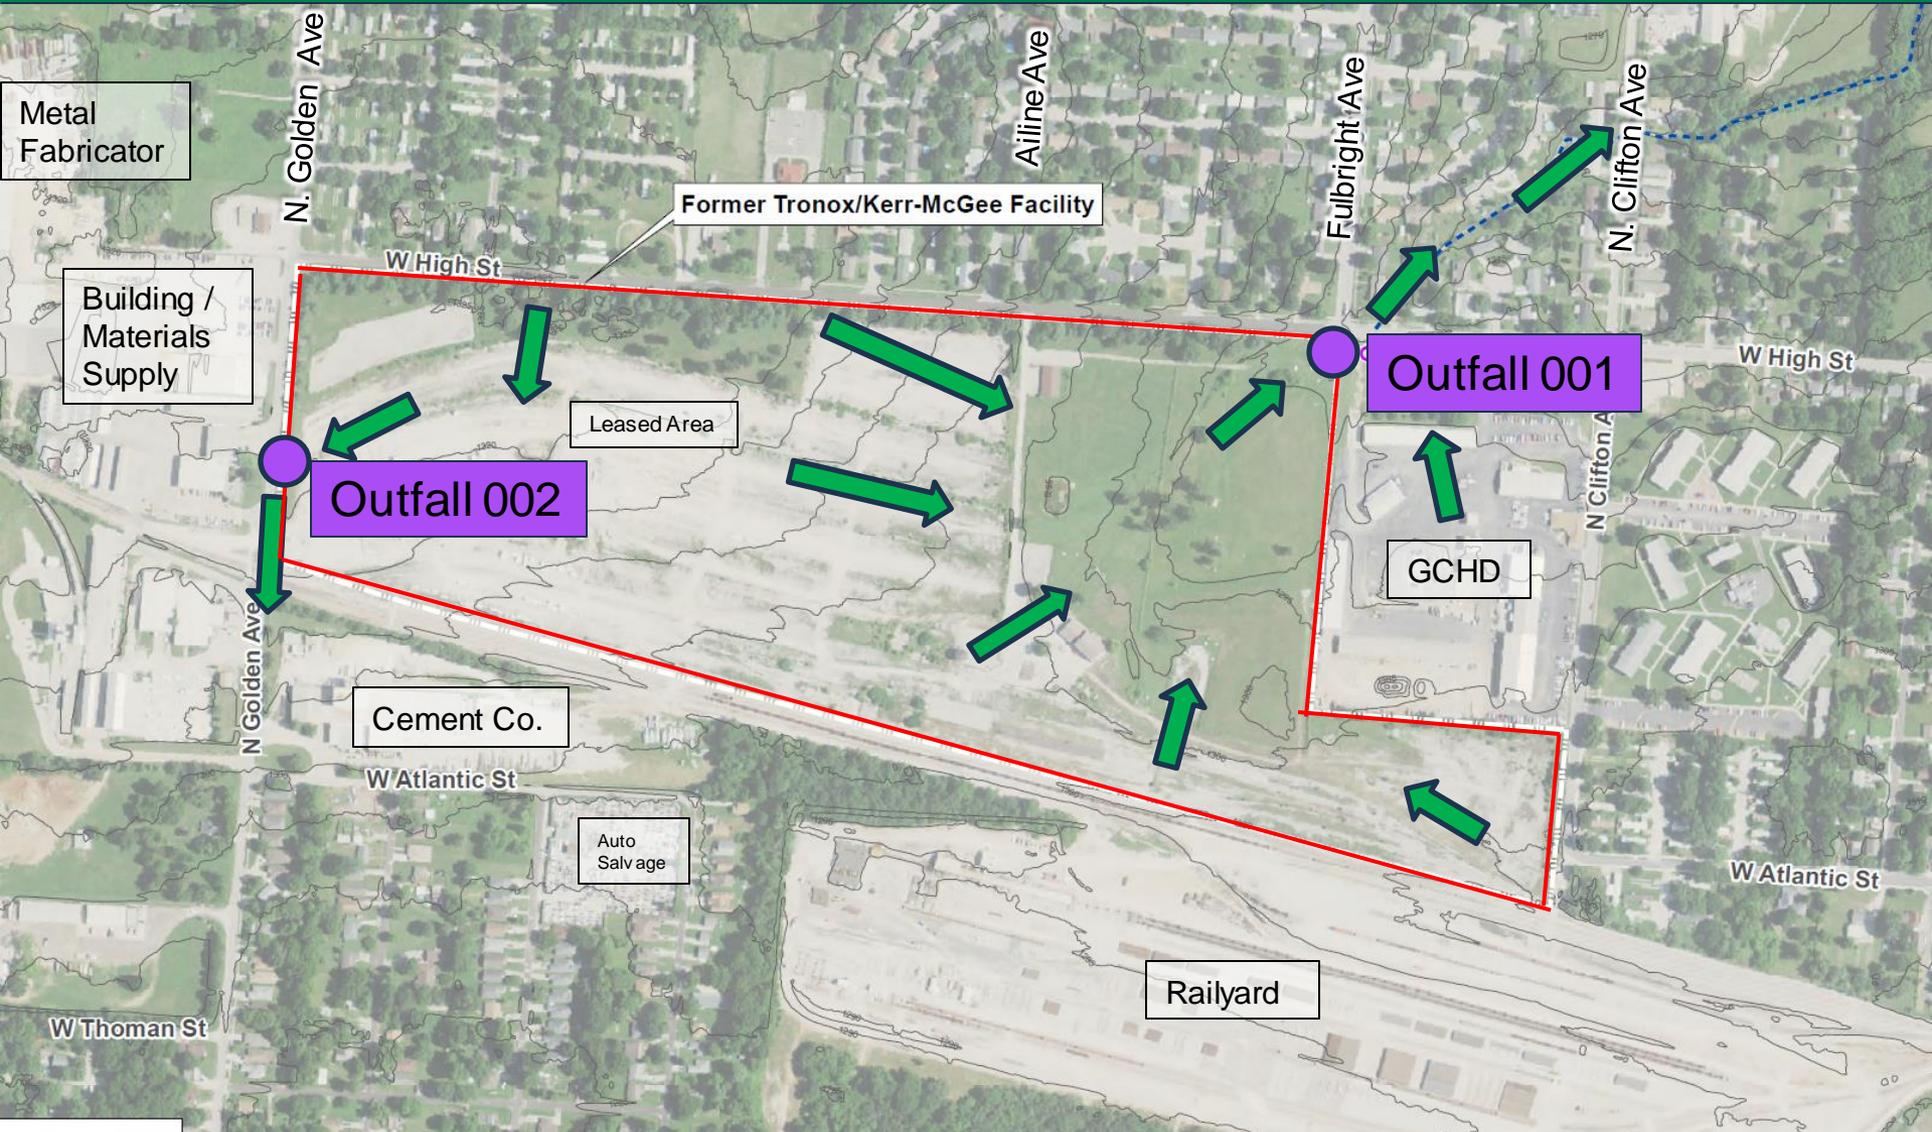
Facility Stormwater and Surface Water

- ✓ Since 1993, Facility has been subject to stormwater regulations
- ✓ Facility is graded such that stormwater leaves the Facility at **only** two locations
 - Outfall 001 and Outfall 002
- ✓ Outfalls are permitted under Missouri State Operating Permit (MSOP) MO-0117331
- ✓ Quarterly sampling and reporting is required

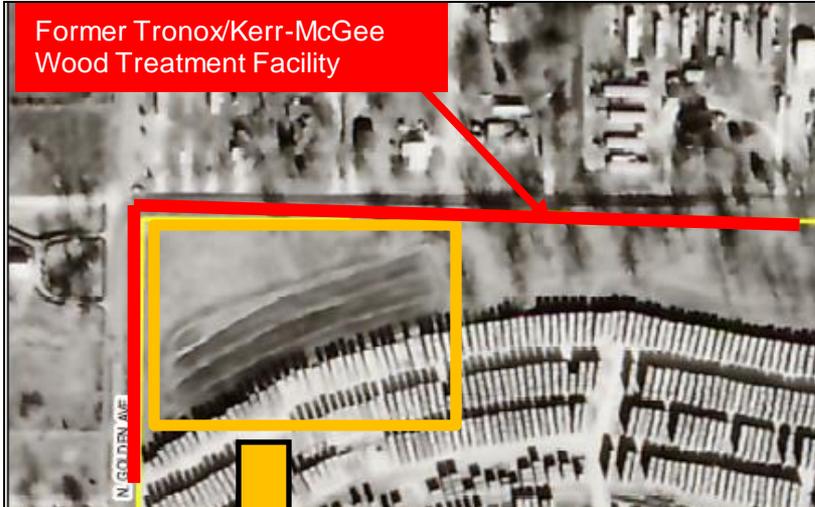
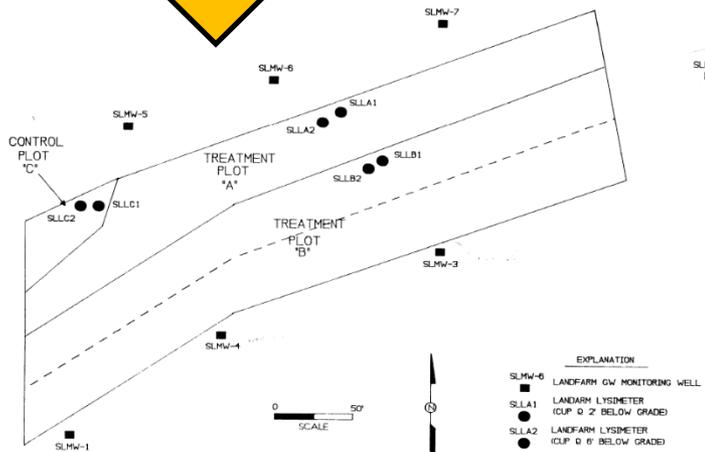
Experimental Land Farm

- ✓ Land farm established to assess treatment of creosote sludges
- ✓ 1979 to 1981: ± 600-800 cubic yards creosote sludge mixed with fertilizer on 1-acre plot in northwest corner of Facility
- ✓ Soil sampled to determine effectiveness and contaminant degradation rate
- ✓ 1980 to 1985: Groundwater monitored quarterly

- ✓ Effective at reducing contaminant concentrations
- ✓ Groundwater data indicated no significant increase in indicator parameters; no adverse impact on groundwater quality
- ✓ Deemed not viable large-scale treatment of creosote sludge
- ✓ Land Farm PCC Plan approved in 1989 by MoDNR
- ✓ PCC Plan required gravel cover (2 feet), fencing, and monthly inspections

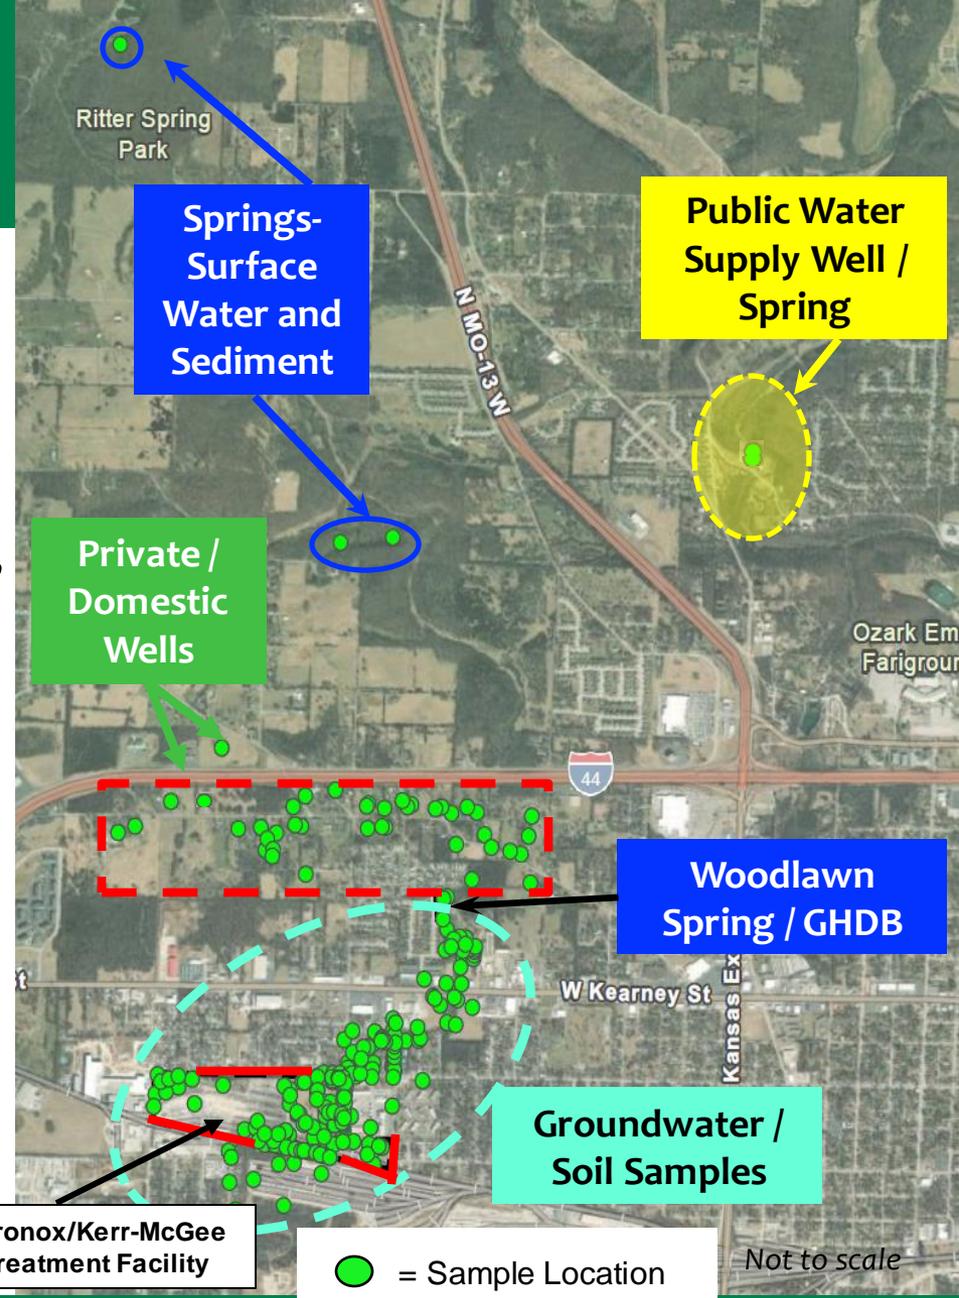
Multistate Trust Sample Locations

✓ Since 2011, the Multistate Trust has collected more than 1,500 samples

- ± 900 total, including groundwater, treatment system, MSOP and Wastewater Discharge permit
- ± 215 soil gas (vapor) / indoor air / outdoor air samples
- ± 75 sewer gas and sewer water
- ± 140 surface water and sediment samples
- ± 10 public water supply samples
- ± 75 domestic well samples
- ± 115 soil samples

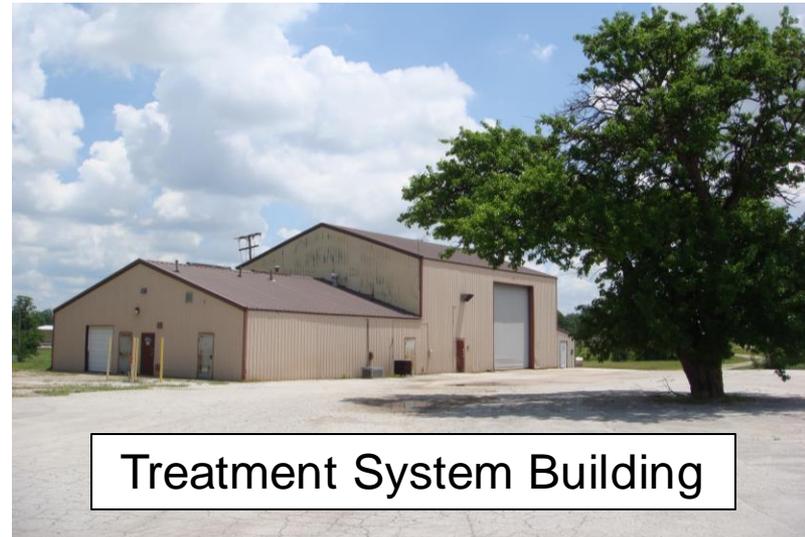
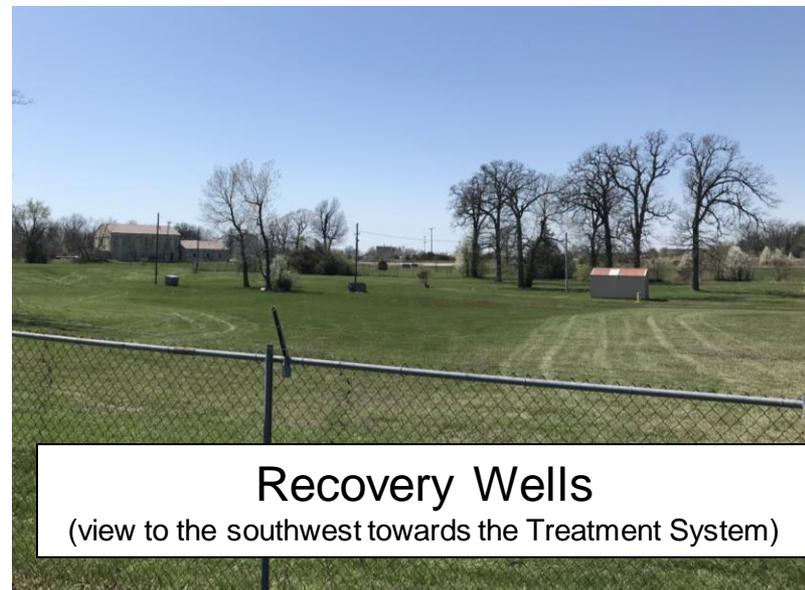
- ✓ Perform post-closure care of HWMUs and Land Farm
- ✓ Operate the treatment system to capture contaminated groundwater and recover DNAPL (as creosote) (groundwater corrective action)
- ✓ Perform routine groundwater sampling

- Recovered more than 6,500^a gallons of creosote
- Treated/ discharged more than ±91,000,000^b gallons of contaminated groundwater

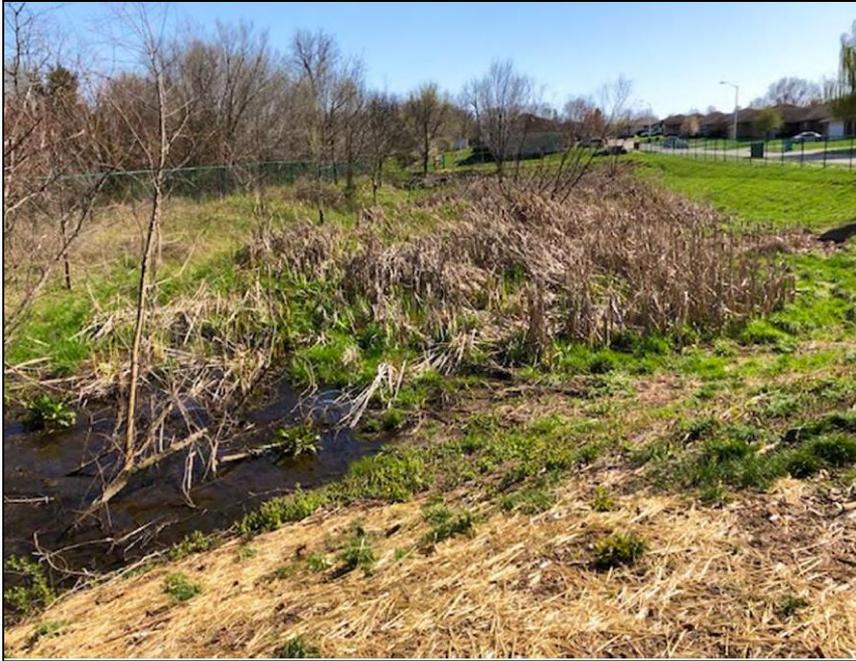
Existing stormwater basin conditions
(April 2018)

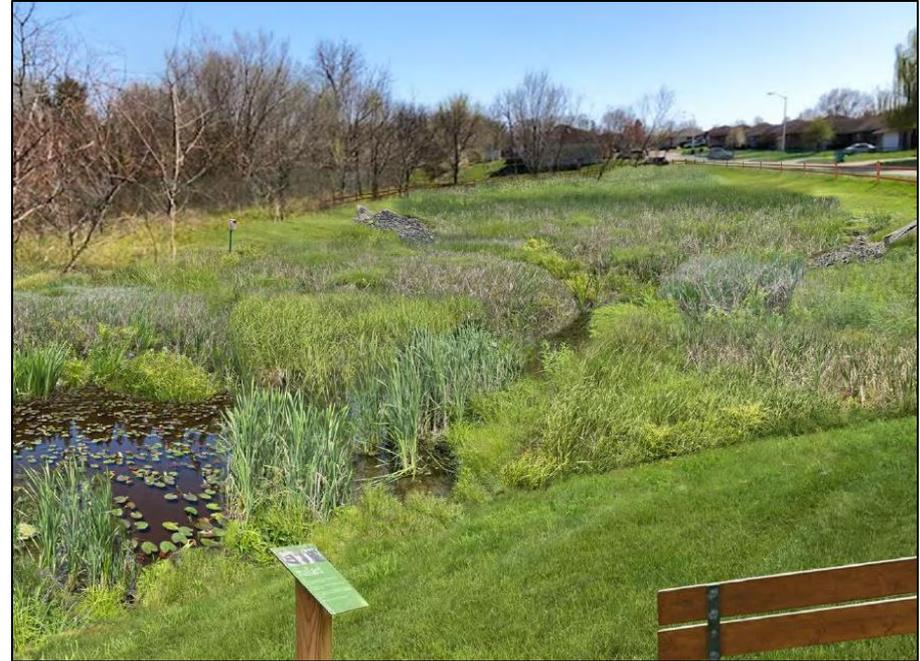
Constructed Treatment Wetlands
(Concept)

- ✓ Continuing to sample Woodlawn Spring/Outfall 003 and GHDB outlet
- ✓ Preparing site characterization/pre-design investigation work plan for review and approval by MoDNR

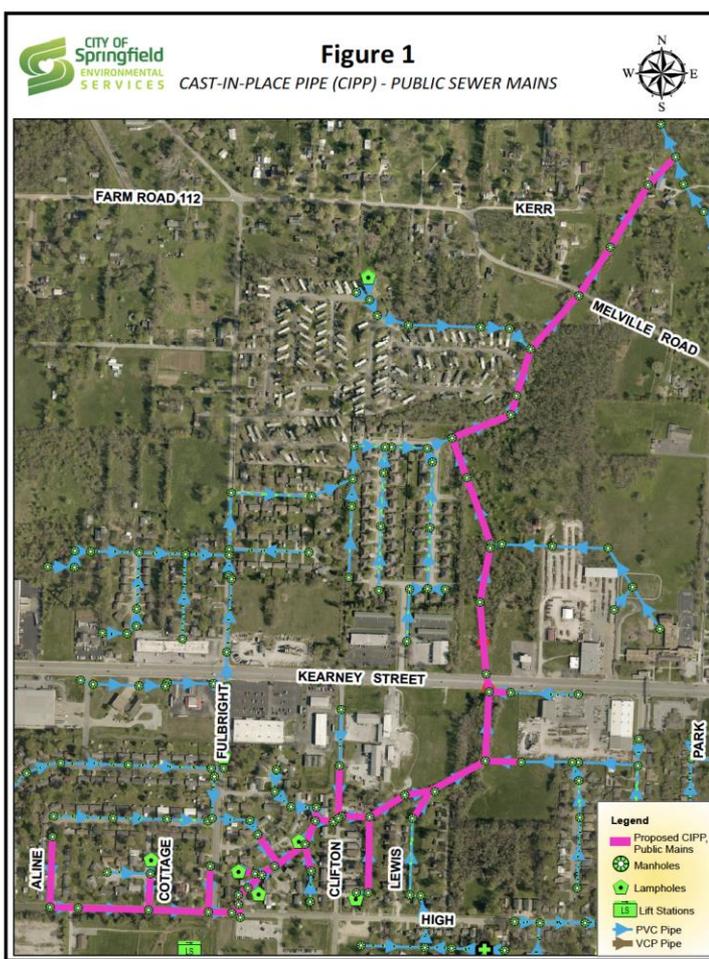
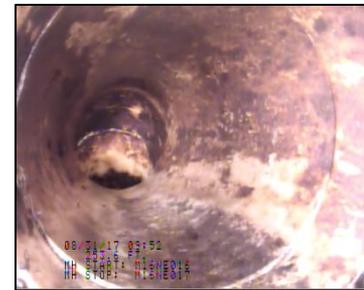
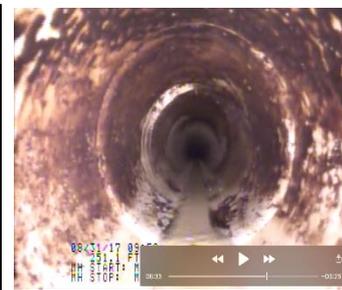
- Known discharges of creosote by Kerr-McGee in 2004
- Sewer pipe is \pm 4–5 feet below ground surface in Clifton Drainage
- Depth to groundwater in Clifton Drainage ranges from 0 to 5 feet below ground surface
- City of Springfield used a video camera to evaluate 9,572 feet of main sewer pipe
- City repaired and trust reimbursed
- Videoed residential residential lateral pipes

- Proximity to Facility and the previously damaged main sewer pipe
- Damage observed at certain residential sewer lateral pipe connections at main sewer pipe by City of Springfield
- Cracked lateral pipes act as potential conduits for vapor migration and transport of contamination

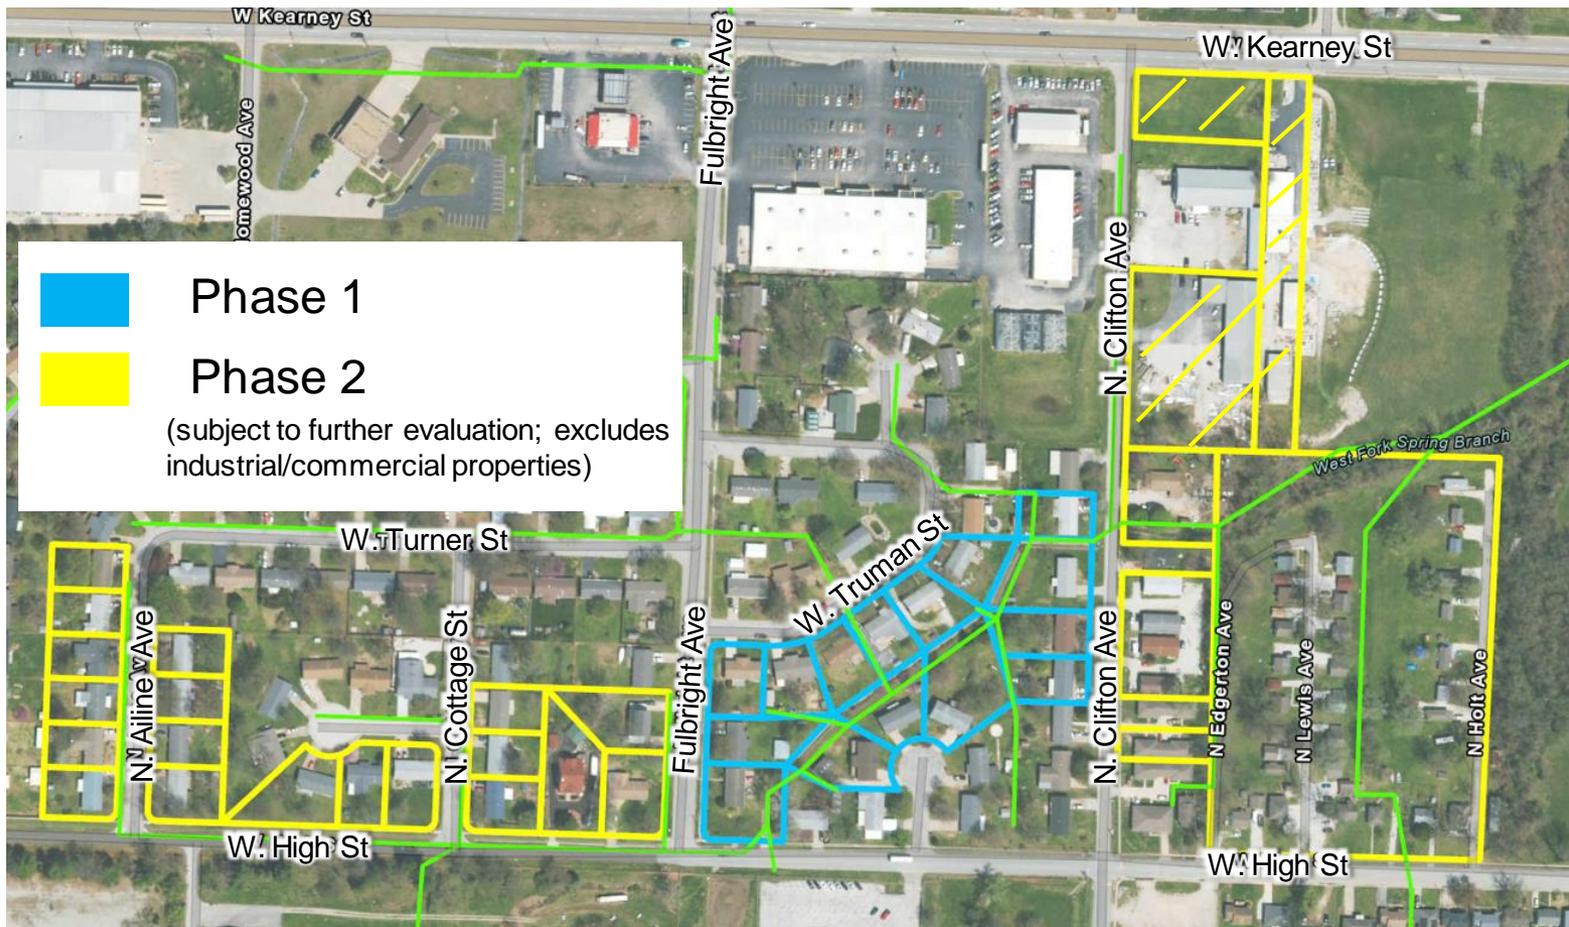
Plan for Replacing Residential Sewer Lateral Pipes

Note: Residential properties only; No industrial/commercial properties
