Former Tronox/Kerr-McGee Facility

Community Update

Springfield, Missouri February 22, 2023

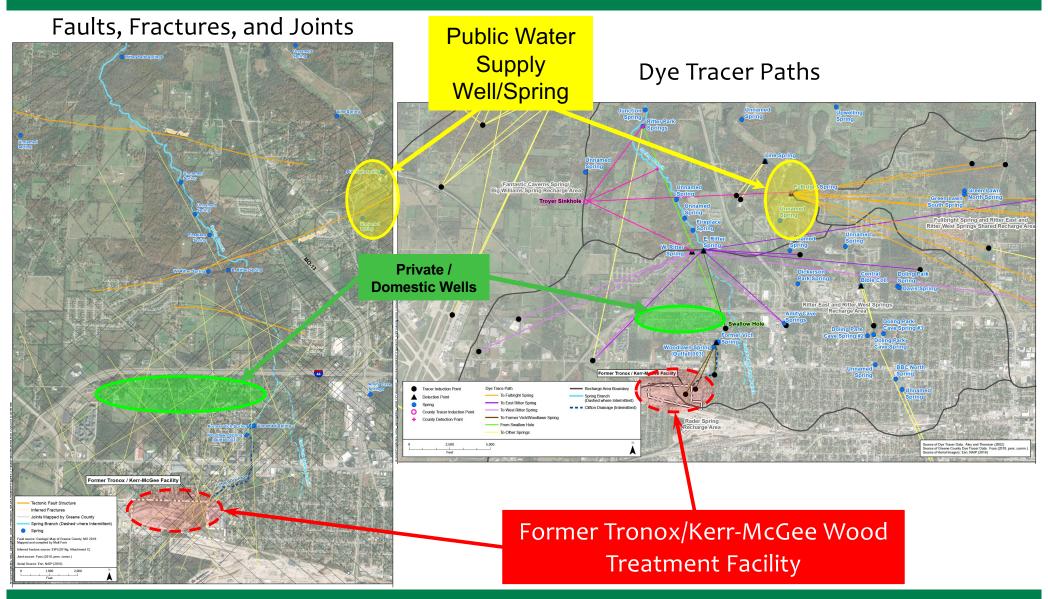
Complex Geology and Transport Pathways

Public Water Supply Well/Spring **Domestic Wells** Woodlawn Estimated Extent of Clifton Groundwater **Drainage** Tronox/Kerr-McGee Wood **Treatment Facility** Creosote visible at surface of Woodlawn Spring

- ✓ Potential to impact the public water supply due to highly complex geology

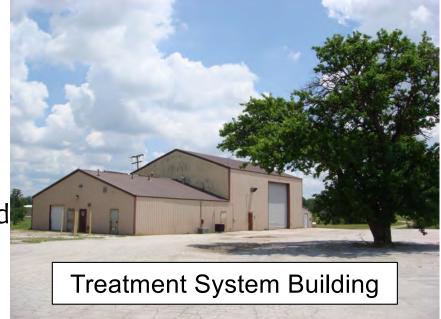
- ✓ Investigated on- and off-Facility soil and groundwater contamination, including Vich Spring and Woodlawn Spring
- ✓ Installation of groundwater monitoring wells and product recovery wells
- Excavated and disposed of contaminated soils
- ✓ Closed land farm treatment unit and 3 lagoons designated Hazardous Waste Management Units (HWMUs)
- ✓ Operation of a treatment system to capture contaminated groundwater and recover DNAPL (as creosote) (groundwater corrective action)
- ✓ Post-Closure Care of HWMUs and Land Farm
- ✓ Routine Groundwater Sampling

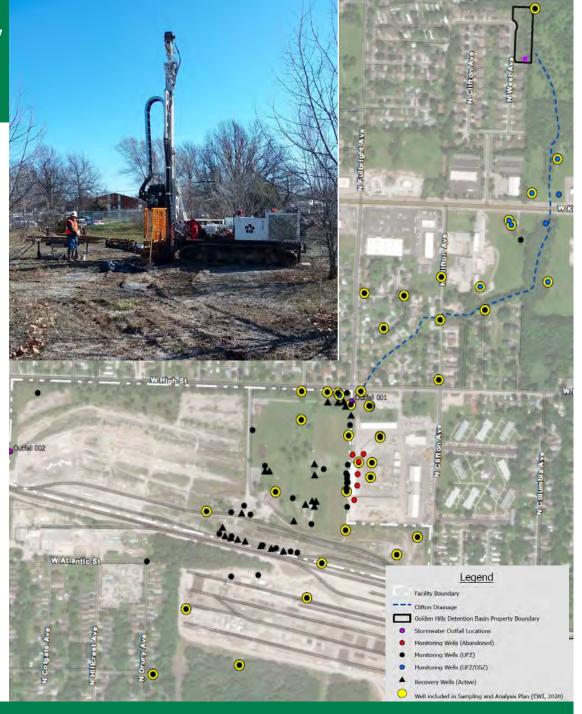
- ✓ Environmental investigations
 - Access agreements, planning, field work and reporting
 - Installation of on-Facility and off-Facility monitoring wells
 - Delineated on-Facility source material delineation
 - Initiated soil gas sampling and drove the development of Vapor Intrusion Investigation Work Plan
 - Installed over 30 wells
 - Collected more than 1000 samples

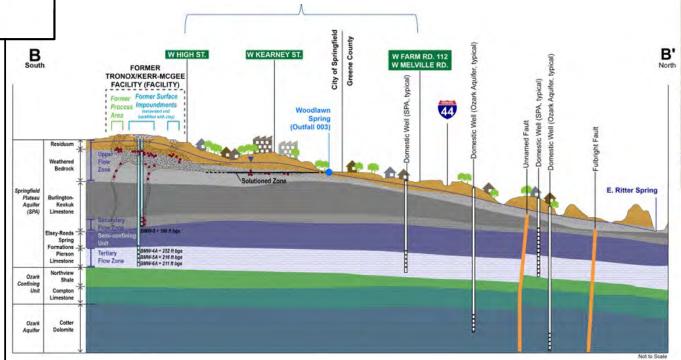
Regional Cross Section

3-D Block Diagram showing regional geology

From Facility (on the right) to E. Ritter Spring (on the left).

Approximately 0.5 miles

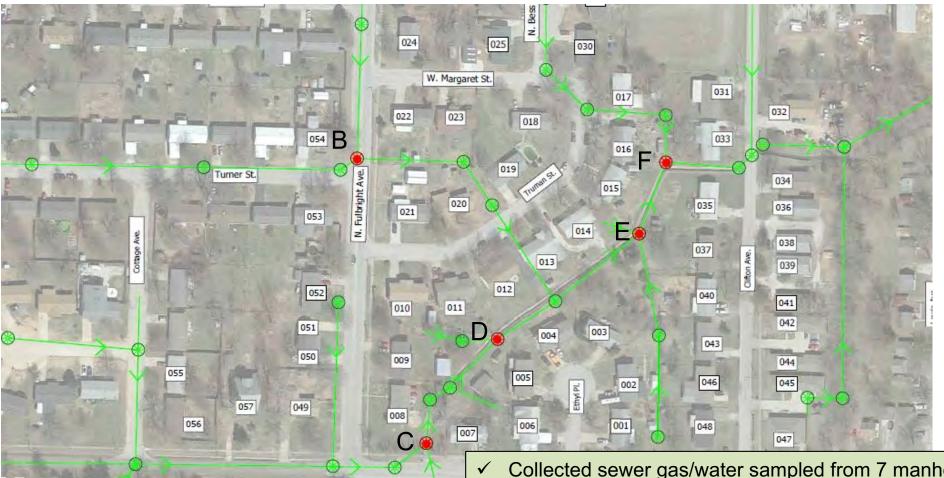
Vapor Intrusion Investigation (Sewer Gas/Sewer Water Sampling Locations)

- Collected sewer gas/water sampled from 7 manholes
- Sewer gas/sewer water results showed concentrations of Facility-related chemicals decrease with distance from the Facility

FACILITY SEWER OUTFALL

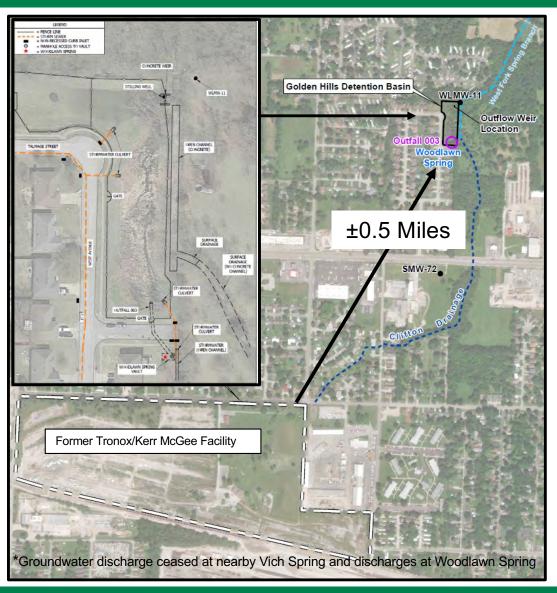
Woodlawn Spring / Outfall 003

- ✓ Discharges into Golden Hills Detention Basin (GHDB) which was constructed in 2000 as a stormwater detention basin
- ✓ Known to be impacted with weathered creosote and non-creosote hydrocarbons

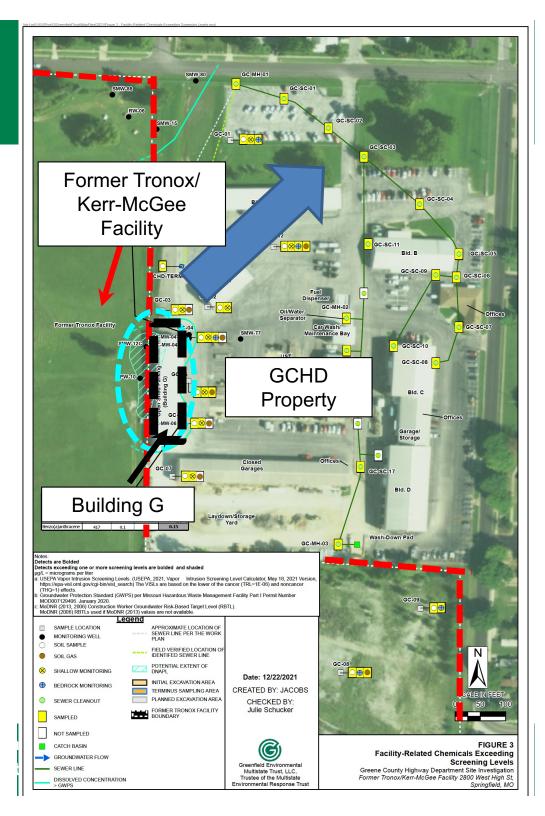
Utility Caution Protocol

- ✓ Provides information and guidelines for utility workers or others performing subsurface work in the designated area
- ✓ Identifies procedures for conducting emergency response/unplanned maintenance and planned maintenance/repairs
- ✓ Used to support soil management for utility excavations
- ✓ Revised as new information is available

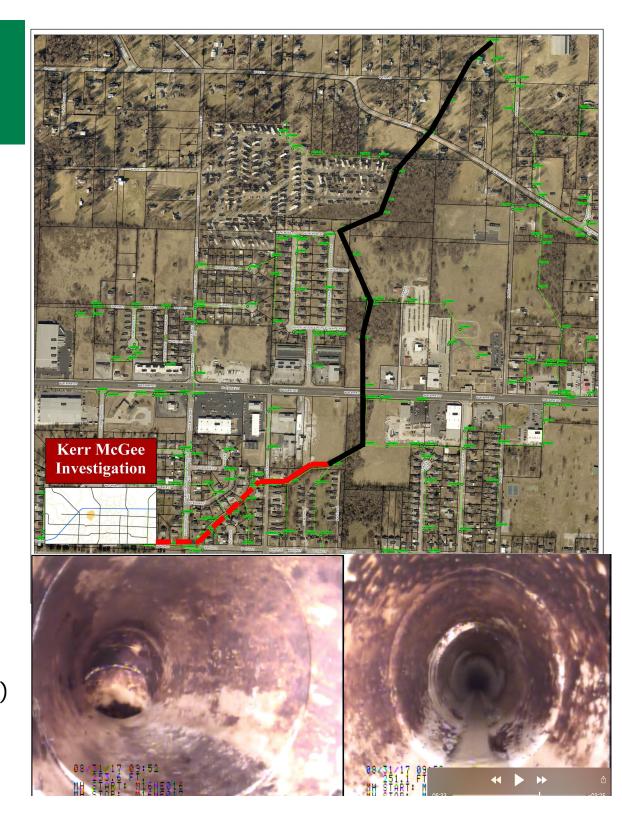
Figure 1
CAST-IN-PLACE PIPE (CIPP) - PUBLIC SEWER MAINS

- ✓ 9,572 feet of City of
 Springfield's Main (public)
 sewer pipe was repaired by
 CIPP methods
- ✓ Repairs to main sewer pipe will prevent contaminated groundwater from migrating via cracked and/or damaged sewer line
- ✓ Multistate Trust reimbursed City of Springfield for this Environmental Action

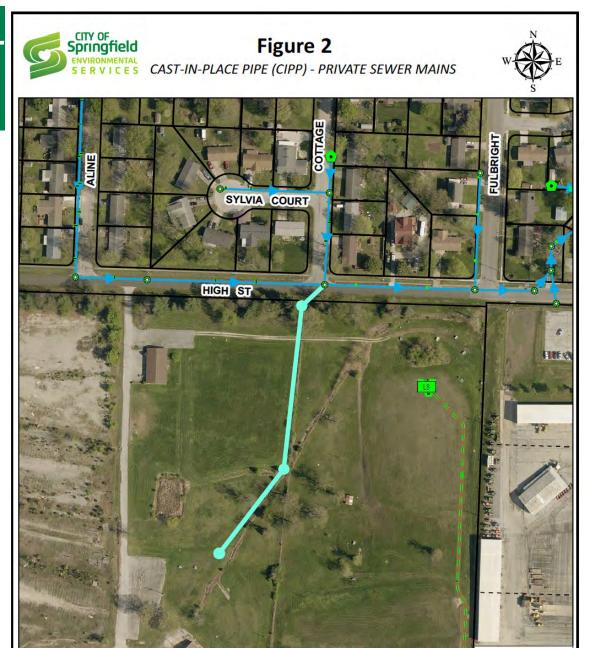
Proposed CIPP

- √ 667 feet of the Facility sewer pipe that connects to the Main sewer line was repaired by City of Springfield for public's benefit
- ✓ Sewer line was repaired by CIPP methods
- ✓ Repairs to Facility sewer pipe will prevent contaminated groundwater from migrating via cracks or damaged sewer line
- ✓ Multistate Trust reimbursed City of Springfield for this Environmental Action

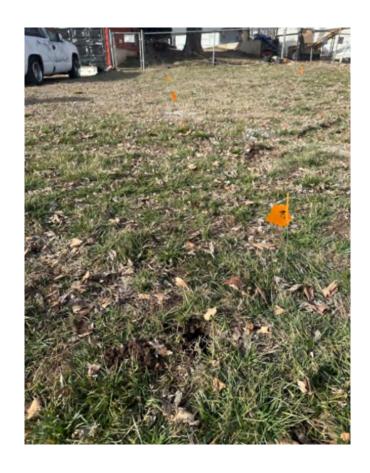
ISM Surface Soil Sampling in Residential Yards

Use of small drilling rig to minimize damage to yards

- ✓ During sewer maintenance excavation black-stained soil was observed at about 3 feet below ground surface
- ✓ 7 properties were identified for surface soil sampling to evaluate risk to human health
- ✓ Results will be used to determine if soils need to be removed from yards
- ✓ Field work began in late-December 2022 (1 property was sampled)

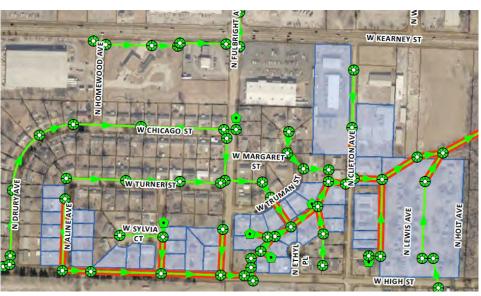
Replacement of Residential Sewer Laterals

- ✓ Initiation of ±30 residential sewer lateral replacements
- ✓ Open cut and replace private laterals and lateral connection

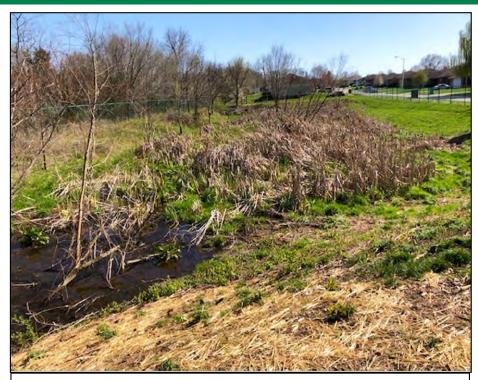
Existing stormwater basin conditions (April 2018)

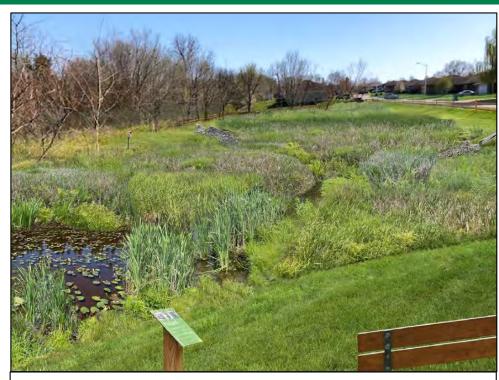
Constructed Treatment Wetlands (Concept)

- ✓ Constructed Treatment Wetland identified as potential revised management plan for GHDB
- ✓ Prepare site characterization/pre-design investigation work plan for review and approval by MoDNR
